FFWPU UK: Cleeve House - Taking Care Of The Roof Over Our Head

Cleeve House

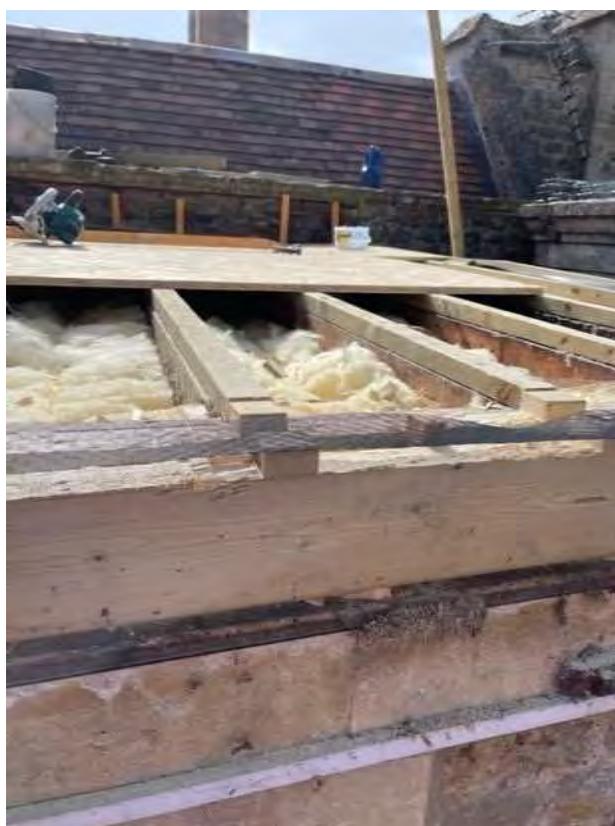
We started with Room 9 - it is a bedroom with an ensuite bathroom that had been out of action for a good couple of years. It had become a storeroom for junk. And for an extended period of time two buckets collected the rainwater from the bust box gutter on the roof above it (pictured right).

A well recommended local roofer, Chris K., came in with his team to fix the box gutter, and soon it was all done, we could then proceed to remove the junk from room 9 and fix up the ceiling and this is what it

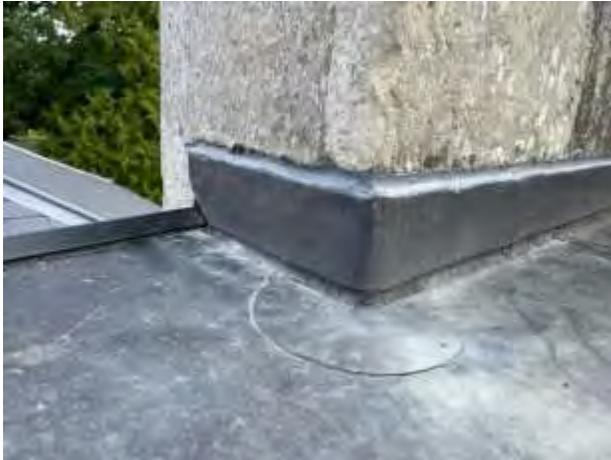
However, while we were up on the roof doing the initial works we had to cross over the flat roof above the ceiling of the main stairwell, and we noticed an issue. The wood under the rubber was all soft and rotting away. (pictured right)

One of the main issues was no ventilation which meant all the moisture inside the building was getting trapped in the wooden structure of the roof. Last week, after a particularly wet summer, we managed to finally strip out the previous work and properly replace the flat roof - not a moment too soon. The furring boards were rotten and the

structural joists holding the roof up were not in good shape. There was no insulation either between the rafters or the furring boards and there was mould. Because of that, a lot of wildlife got stuck into the rotten timbers.

The roofers soaked the wood we could keep, with chemicals to prevent any further wood worm, and then got on with restoring the flat roof without damaging any of the new plaster and paint on the ceiling on the other side, firstly putting in the new timber and insulating.

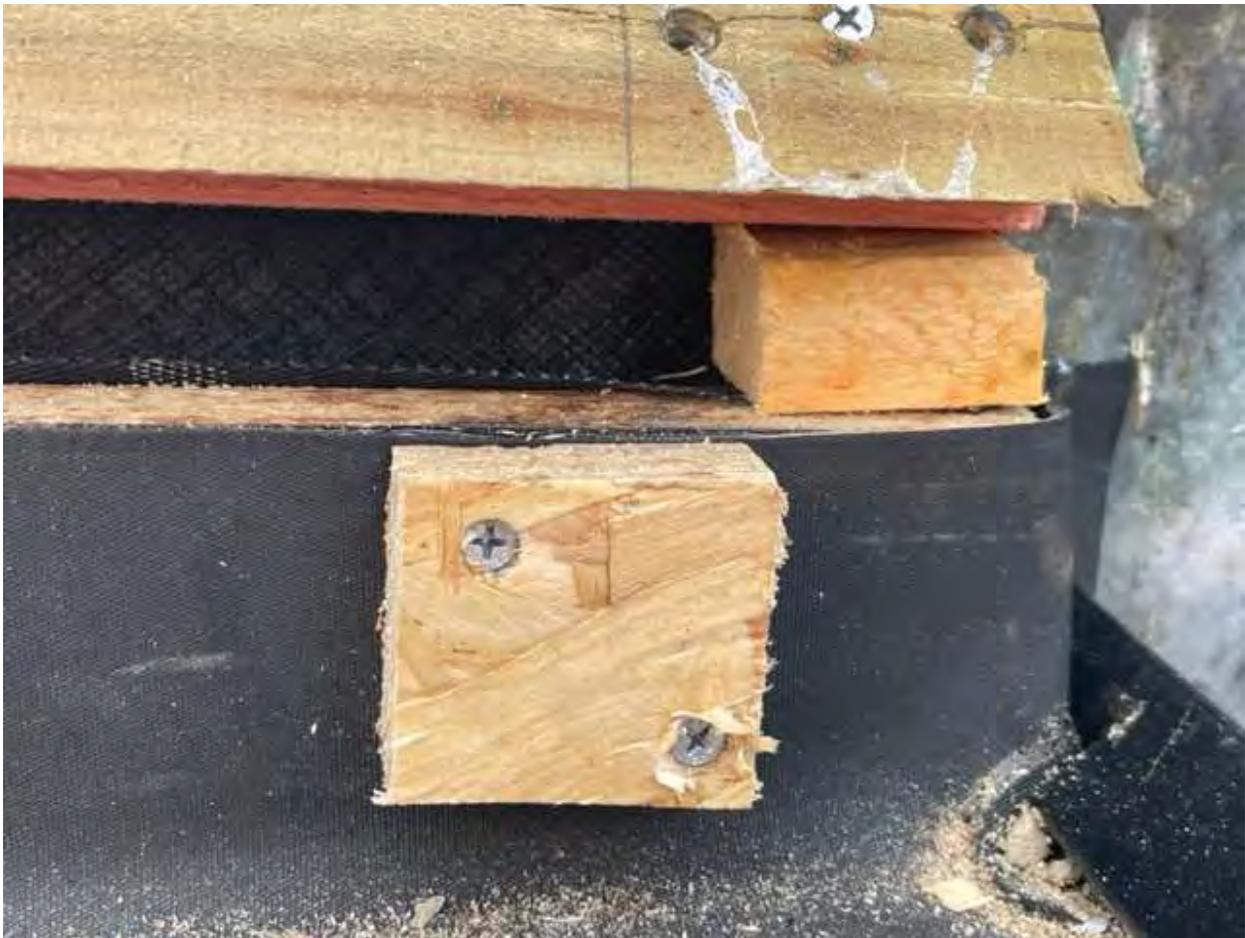
I spent time documenting the work they did, the different materials such as the Restrix rubber that they put down to replace the cheap poor-quality rubber used four years ago. There is a joy in watching people who take pride in their trade doing a good job and listening to them explain how and why they go about each task in a particular way.

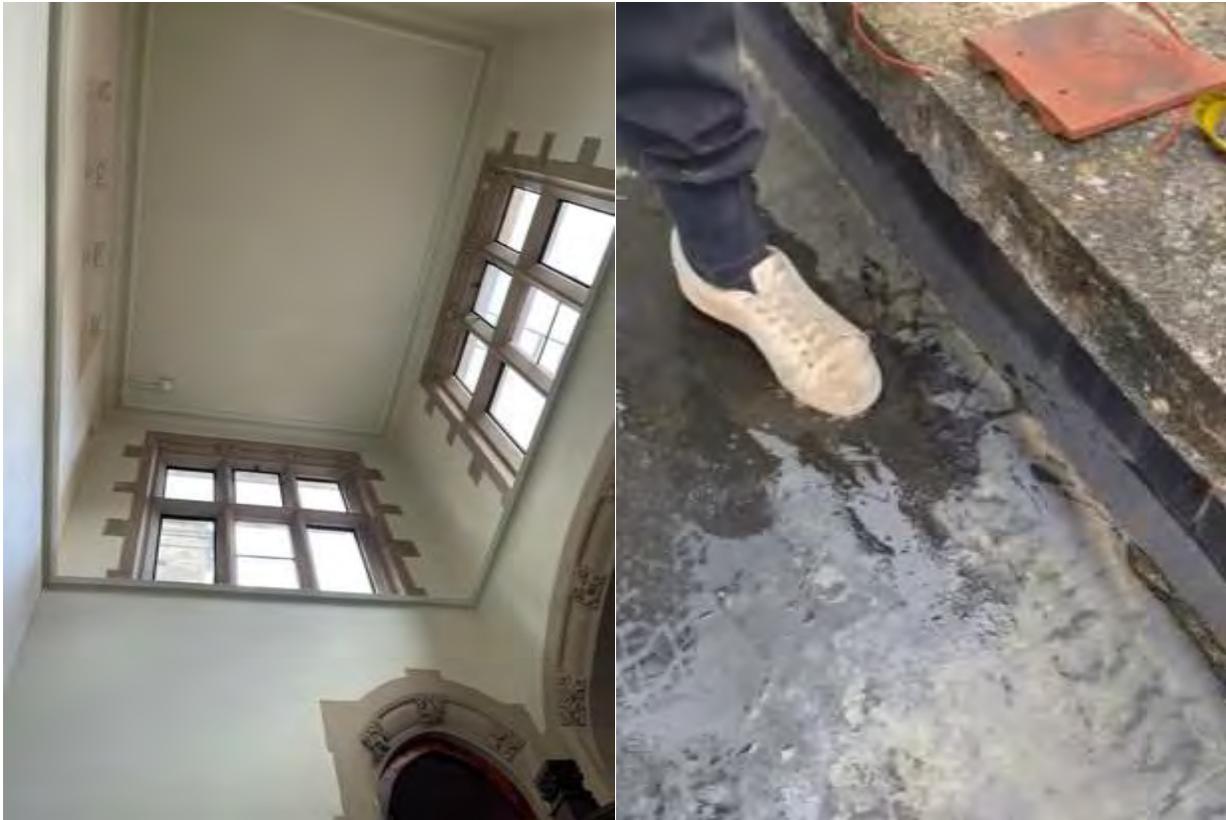
However, while we were up on the roof doing the initial works we had to cross over the flat roof above the ceiling of the main stairwell, and we noticed an issue. The wood under the rubber was all soft and rotting away.

One of the main issues was no ventilation which meant all the moisture inside the building was getting trapped in the wooden structure of the roof. Last week, after a particularly wet summer, we managed to finally strip out the previous work and properly replace the flat roof - not a moment too soon. The furring boards were rotten and the structural joists holding the roof up were not in good shape. There was no insulation either between the rafters or the furring boards and there was mould. Because of that, a lot of wildlife got stuck into the rotten timbers.

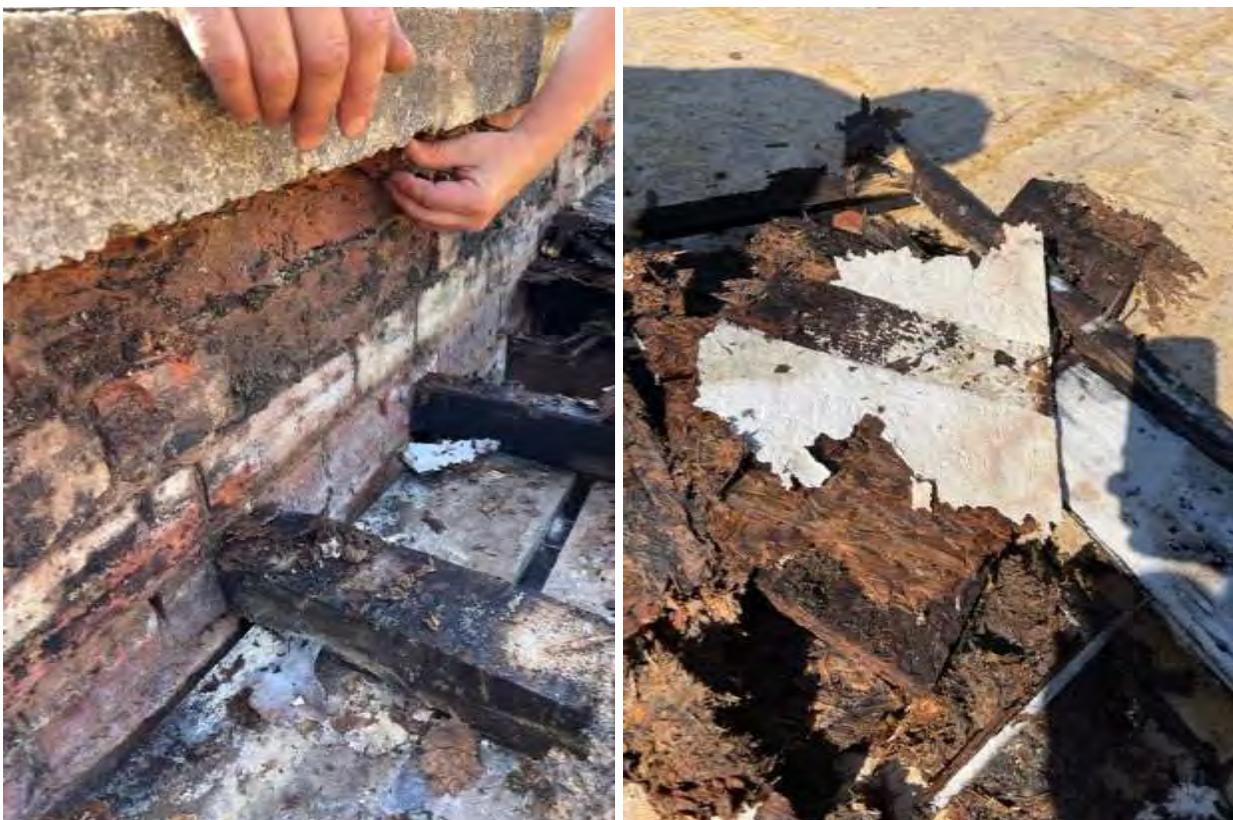
Redecorated ceiling of the roof above the main stairwell and the moment the soft wood was discovered
